Orbit Design Limited 7" (178mm) Diamond Link Hinge

Test Report No: R4790703268-2

Project No: 4790703268-2 Date: February 16, 2023

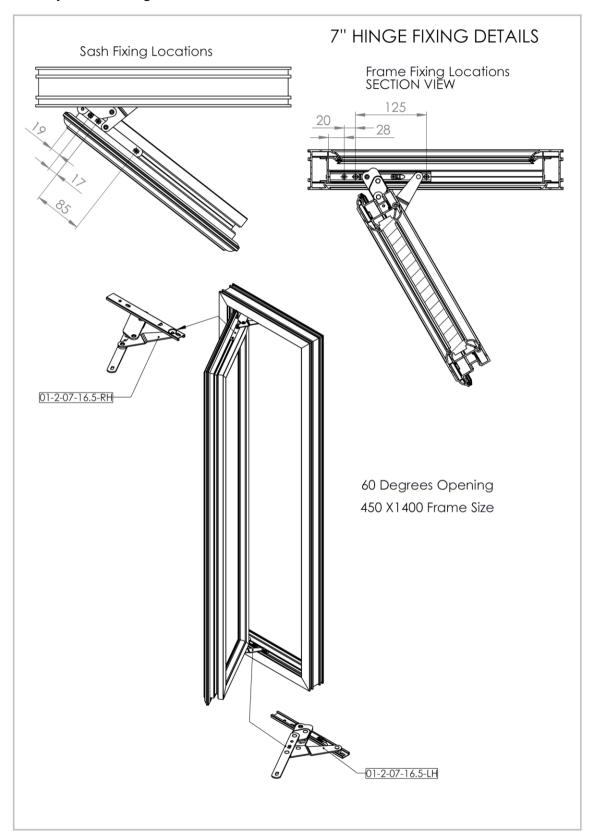
7. **System Drawings**

See Section 7 for test sample drawings as supplied by Orbit Design Limited.
